# CONSEQUENCE OF THE FLASH FLOOD IN THE MALA FATRA MOUNTAINS

*In 2014 a massive landslide due to extreme rainfall in the Mala Fatra mountains occurred. It caused also consequential damages that indicate typical symptoms of "domino effect" due to extreme weather event. A torrential downpour resulted in flooding that caused an avalanche of rocks, mud, wood and other material which buried parts of Vrátna Dolina and engulfed a lift station to Snilovské Sedlo. Dozens of cars were destroyed as was a road leading from Terchová village to Vrátna Dolina. Vrátna Cottage, road infrastructure and a part of Terchová village were damaged as well. About 200 people present at the area of the natural disaster managed to shelter in nearby buildings and nobody was hurt or killed. Vrátna Dolina resort has a lot to clean up after the disaster. Flood cleanup bill is estimated at tens of millions Euros. Unfortunately, more landslides could follow in the future. The clean-up operations were realized by the integrated rescue system bodies, civil protection, fire and rescue services, municipalities, local governments and other organizations.*

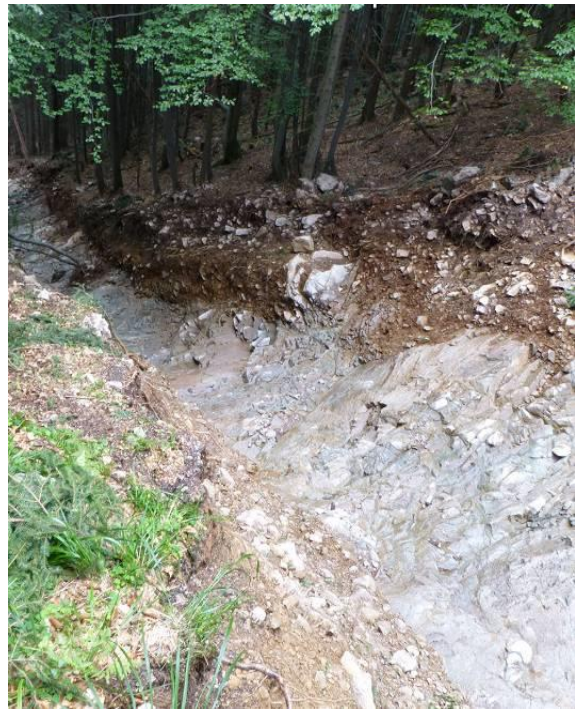
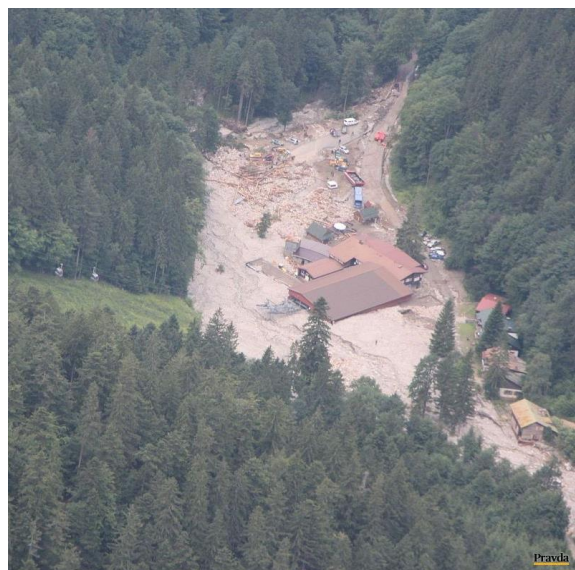
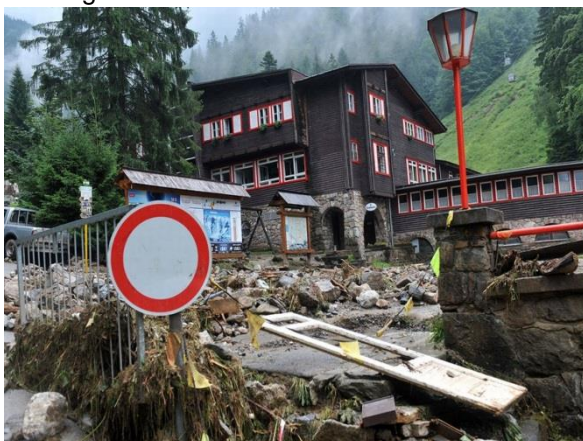
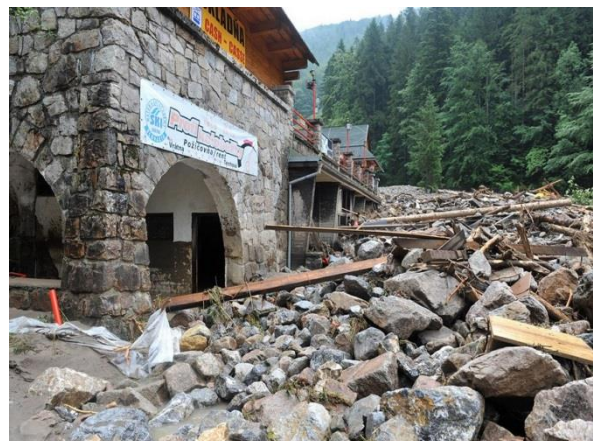
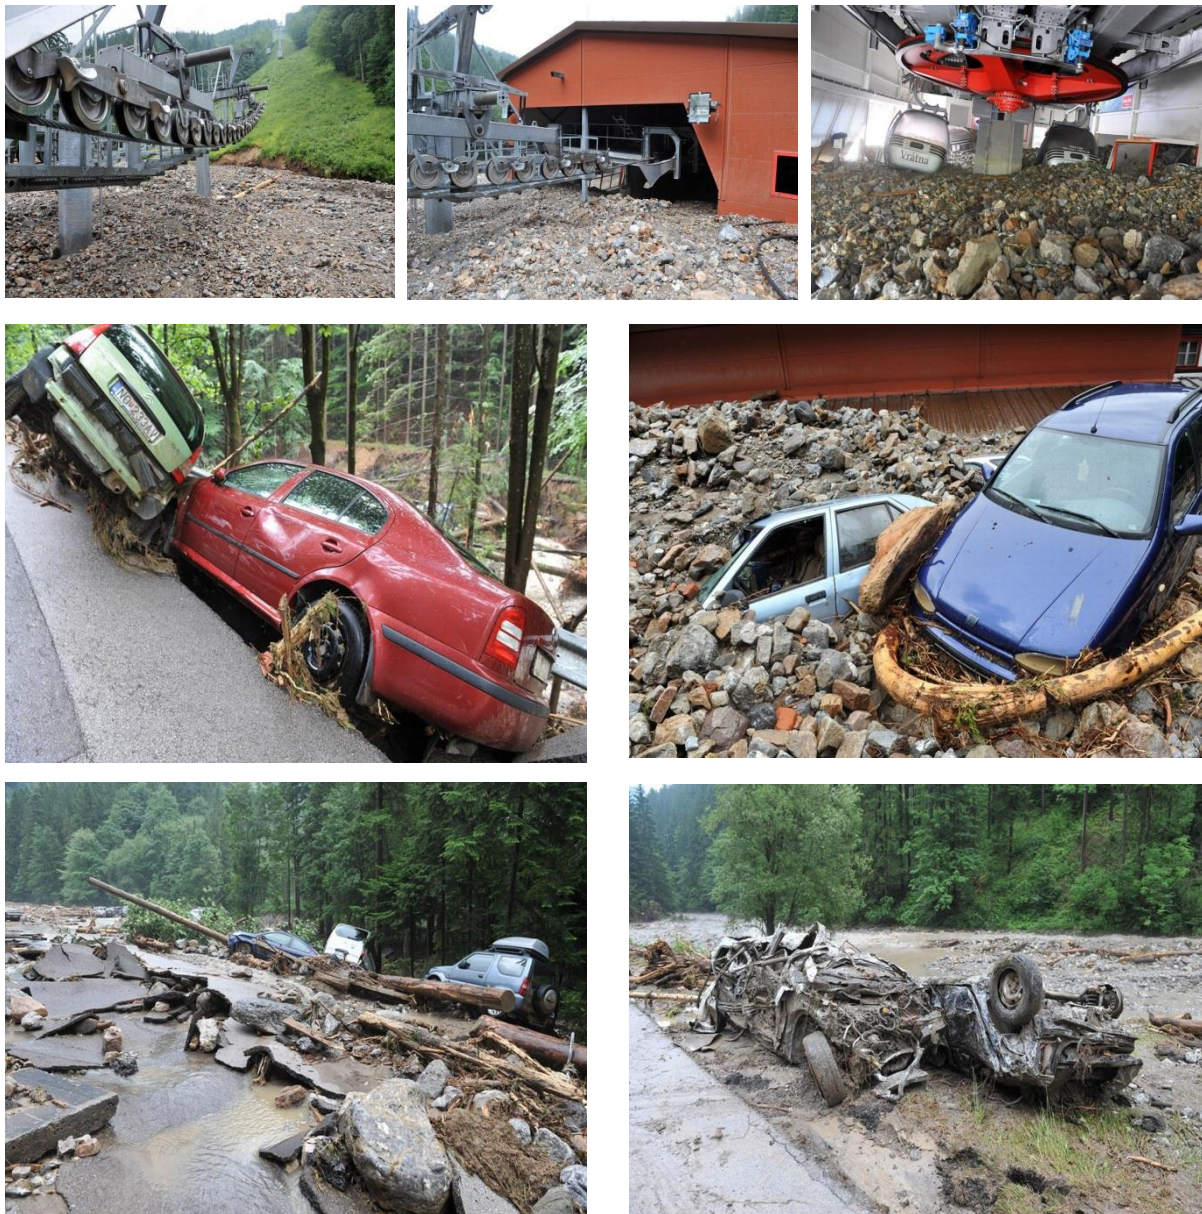
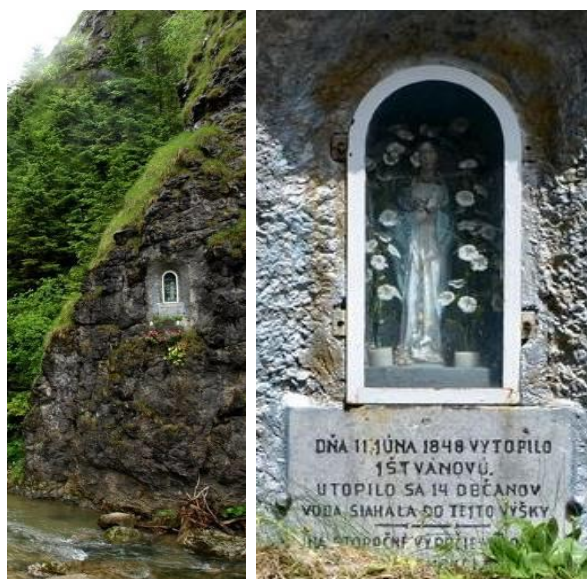
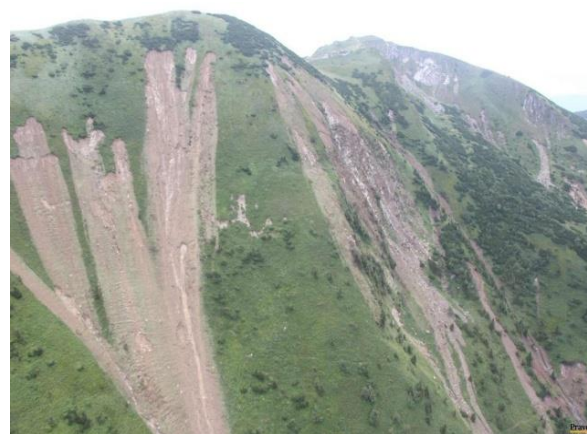
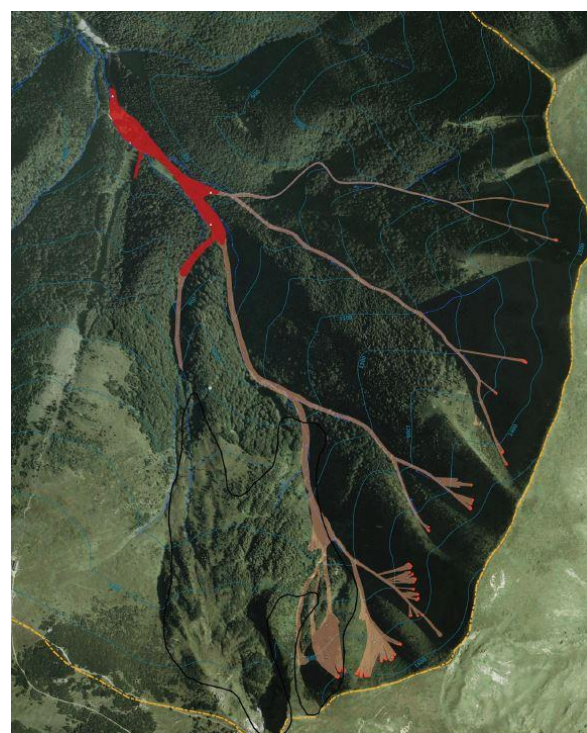
Fig. 2 Photos of landslides effects

and muddy streams - "mury" - of a thickness of 1-2 meters. Landslides were conditioned by the favourable inclination of the bedrock together with the wetted plant cover. As a result, many relatively small "plates" of slide material broke (each of which reached the size of several 100 m<sup>2</sup>) and moved particularly through avalanche gutters at the rate of 10 to 20 m / sec (web geology 2014).

Approximately 800 meters above the cottage Vrátna individual flows "mury" started to meet. The stream continued through a narrow valley, and took with itself other bottom sediments that had been accumulated there in the previous period and other small streams from side valleys were affixing it up to the point when a mixture of rocks, mud and trees reached thickness of about 2 meters. Most streams eroded valleys down to bedrock (web geology 2014).

The front part of rocky and muddy stream flow reached the cottage Vrátna with the base station of the lift, in which, although there was extensive material damage, there was no serious damage to buildings and static lift columns. According to the testimony of those present the rocky flash flood was stacked gradually, so it did not come to a single impact of the front part of the stream directly into the building with the lift – otherwise there would undoubtedly have come to a total destruction of buildings and other infrastructure there.

The stream flow broke into the cottage and the building with cable cars and totally devastated the interior up to the second floor. In the cottage at that time, there were approximately sixty people, including children, in there who managed to escape to the upper floors. In case of a total destruction of the buildings in the area their chances would have been unpredictable.

Further stream course was incredibly devastating. On the terrain breakage under the cottage it gained speed, swept away vehicles from the parking lots, destroyed and took with itself an asphalt road in the length of several kilometres, whereas in wider areas it stored drifting natural material, vehicles, cottage furnishings. Just having observed the position of those damaged vehicles one can estimate the stream's height and strength. See pictures from (Youtube 2014 A, Youtube 2014 B, & Youtube 2014 C)

infrastructure in the local part called Starý dvor and then it reached the part Tiesňavy. In the narrowest part the stream reached the height of about five metres, it washed the original rock bed by about one metre and scoured the only access road in length of about two-hundred metres as well. In some places it also demolished retaining walls. After its intrusion to the village Terchová it spilled over and flooded the village land, basements and some houses as well. The mainstream stayed in the original, modified riverbed and demolished several local bridges and partially destroyed stone trough lining.

- Decisive conditions for the creation of catastrophic flash flood in the area there were favourable geological and geomorphological conditions (presence of marl in the jointing area with layers / schistosity in conformity with the slope, a large catchment area converging into the funnel above the lower lift station). For immediate launcher we consider extreme rainfall.
- An important finding is the fact that the slopes in their upper parts (jointing area) of the mountains Mala Fatra are saturated and loosen – in case of extreme rainfall the situation could repeat.
- It is recommended to update the geological map at a scale 1:10,000 in the area of interest. Such a map is essential for drawing up maps of hazard.
- Due to the difficulty of the terrain and partially impassable ground it is recommended to perform air photogrammetry or aerial laser scanning in the affected area.
